**Vegetative Sampling Results Summary**  
**In Support of Health and Safety Plan**  
**For Vegetation Clearing and Grubbing**  
**West Lake Landfill Operable Unit 1, Bridgeton, Missouri**

**March 30, 2009**

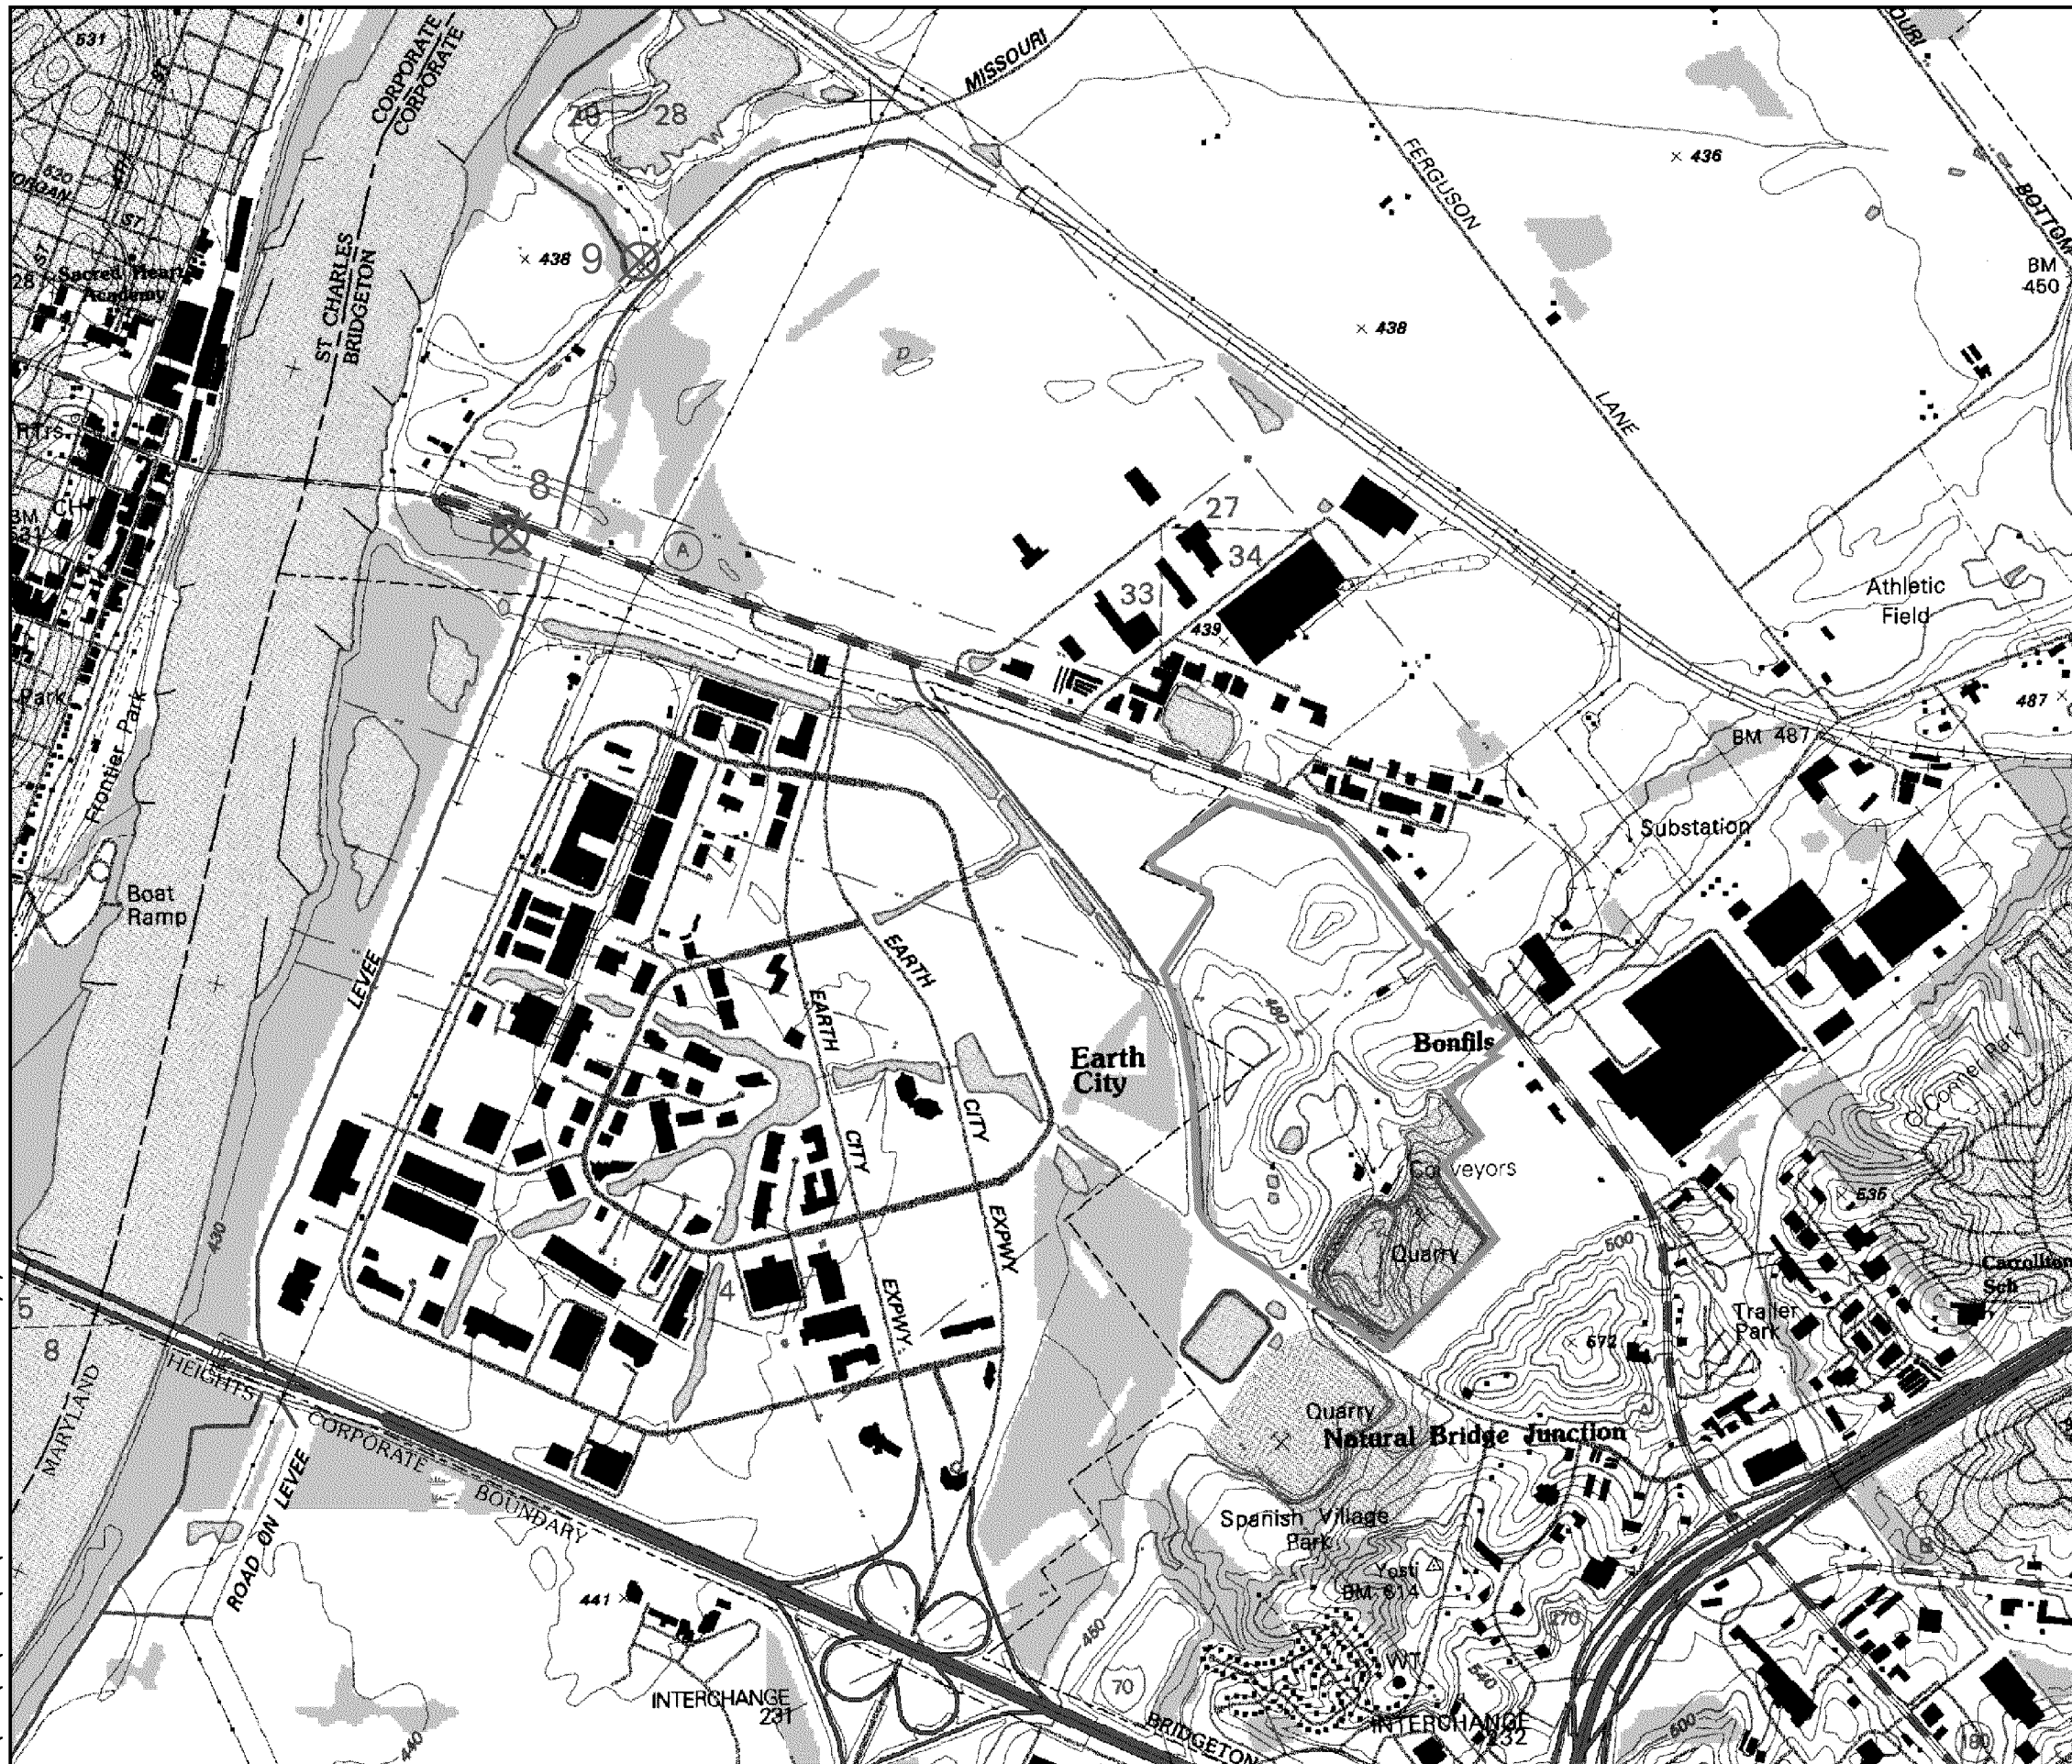
In addition to the collection of samples from areas with low gamma values within Areas 1 and 2, two vegetation background samples were taken from outside of Areas 1 and 2. Figure 2 shows the background sample locations in relation to the West Lake Landfill site. These background samples are numbered 8 and 9 on Table 1 (Vegetative Sampling Results). The background samples were collected along the Missouri River at the end of St. Charles Rock Road.

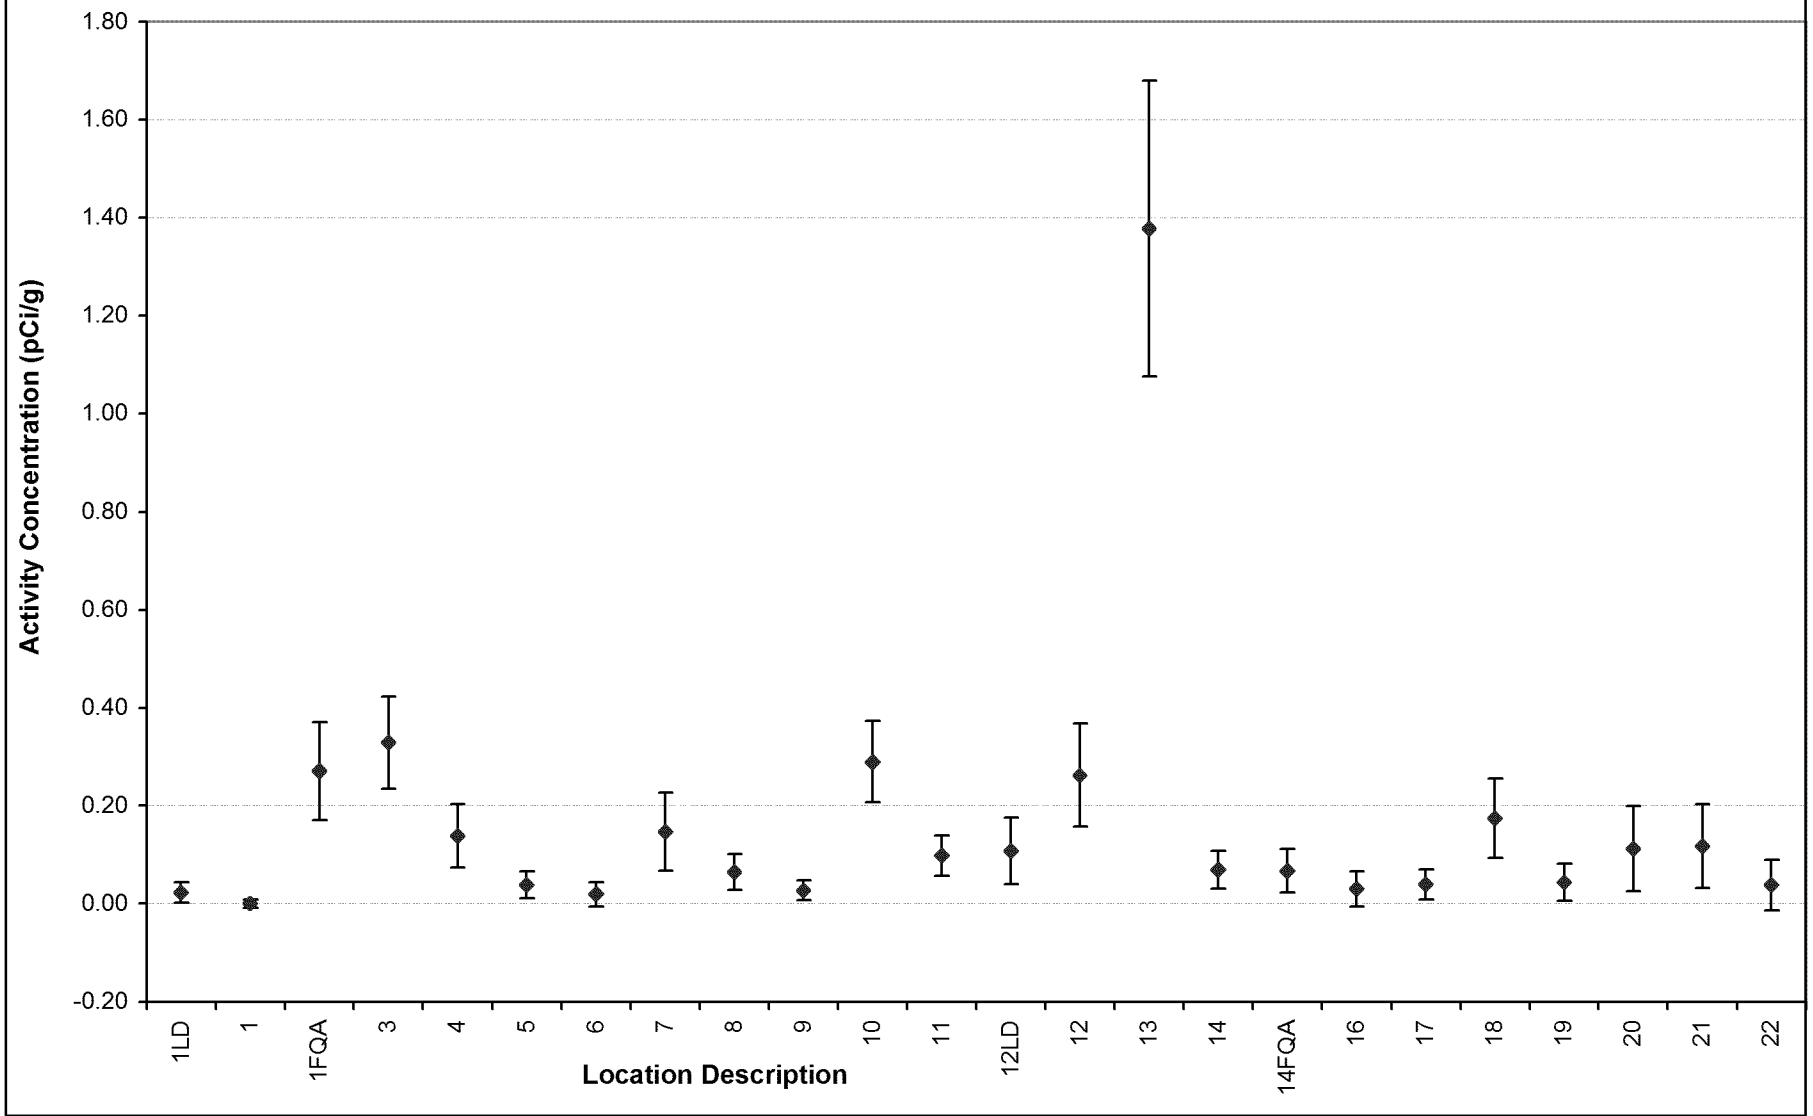
Figure 3 - Ra-226 in Vegetation

The data collected as a result of this sampling effort can be found in Table 1. Results reported in picocuries per gram (pCi/g) are provided for each of the various nuclides for each sample. Figures 3 through 9 show the activity concentrations and uncertainties for each of the samples for Radium-226, Thorium-228, Thorium-230, Thorium-232, Uranium-234, Uranium-235, and Uranium-238, respectively.

The highest activity concentration from the vegetation sampling effort is 1.38 pCi/g for Ra-226 from sample location 13 (Figures 1 and 3). All other results for Ra-226 were less than 0.33 pCi/g. This activity concentration of 1.38 pCi/g for Ra-226 found in one vegetation sample is only slightly higher than the background level of 1.3 pCi/g for Ra-226 in soil discussed in the Remedial Investigation (EMSI, 2000) and significantly less than the 5 pCi/g plus background soil cleanup level for Ra-226 contained in the Record of Decision (USEPA, 2008) for the Buffer Zone/Crossroad Property.
